Manhole Inspection Summary

Manhole # S63A1_005MH

Inspection ☐ Is Incomplete Rating: **3) Fair**

Location Address: **2220 Vail St.**

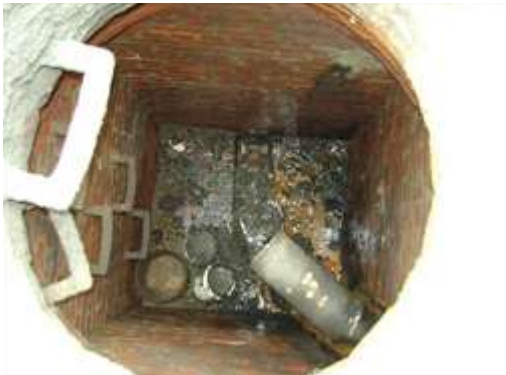
Top View

Comments **ENTIRE CHANNEL IS CLOGGED WITH DEBRIS AND THERE ARE MANY SOURCES OF INFILTRATION PRESENT, SEE PICTURES.**

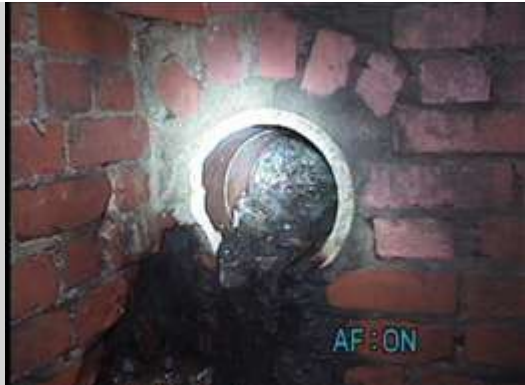
6 O'Clock Inflow

6 in. Circular Gravity Sewer
Pipe In @ 6 O'Clock

Infiltration: **None** Pipe Seal Cond: **Sound**
